Technical Bulletin – 21/09/2017

Bikes Affected: 2017 MX-10, 24.0R, 24.0Jr

Throttle Improvement for potential water Ingress.

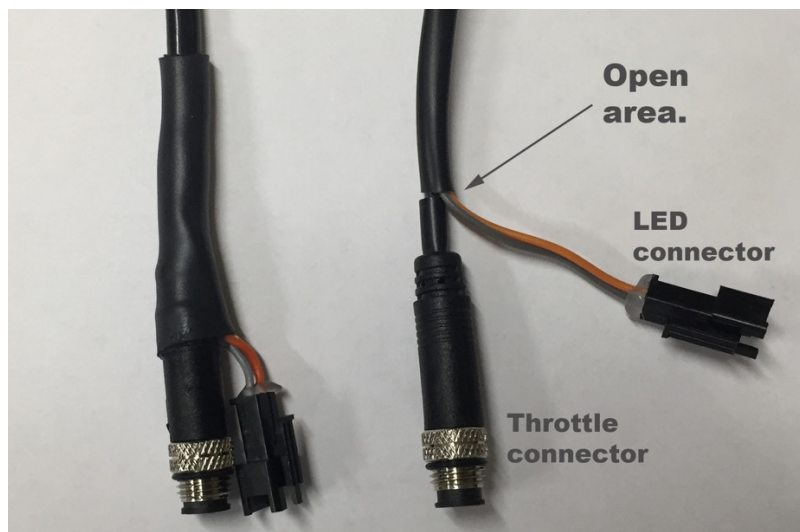
A small percentage of throttle connectors have been found to be vulnerable to water ingress in extreme conditions. Vulnerable throttle connectors are those with the opening oriented at the top side, where water and gravity allow ingress down the top of the connector. All OSET 24.0's sold before October 2017 are in this category, as well as some OSET MX-10's. All other bikes in the OSET range should have the opening at the bottom end, so are not vulnerable. This can be checked very easily on all models.

As shown in the picture below, the standard connector (right), when mounted in the 'upright' position has some vulnerability to water into the throttle connector. The throttle connector itself is IP67 compliant, and should not allow water any further. However, in extreme testing it is possible to force water through, leading to erratic throttle behaviour.

Figure 1. Modified connector on left.

The modified connector (left) has a secondary seal of silicone around the open area, and a third level protection of high quality glue lined heat shrink. This is a simple modification that significantly increases water protection.

This modification should be done by OSET staff to ensure its effectiveness. OSET will modify any throttle sent to us and return it free of charge, with a 1 day turnaround. This is for any dealers or customers. Please return throttles to the address above.
